PROBE TIPS #11

A Technical Bulletin For Probing Applications

Probe Mark Analysis

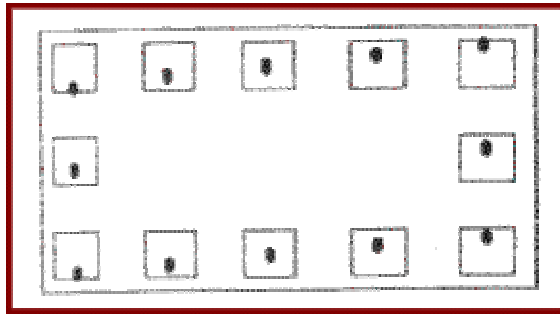
X- Y Alignment

X- Y alignment is perhaps one of the most common problems. It is the most visibly obvious problem and is very simple to correct. Probe placement should always aim to hit the approximate center of the test pad after applying overtravel. When examining a device which has been probed, it is easy to spot probe misalignment since the resulting scrub mark will be visibly off center on the test pad. A common technique used by some manufacturers is to design into the test pad a circular target, which represents the tolerance range within which the mark must hit. Such a technique forces the establishment of a target specification and speeds up the visible QC process. If alignment is found to be visibly off center due to the amount of overdrive and the size of the pad, the target specification was not met. If such misalignment is found, the probe could be scrubbing into the glassivation and quickly contaminating the probe tip, contributing to decreased probe tip life. Worst case scenario, the glassivation is broken and the part is scrapped. Alignment problems could indicate a faulty setup procedure or a careless/ inexperienced operator. The most common alignment setup error is theta adjustment (rotational error). This is indicated when the probe marks on one side of the die are toward the outside edge of the pad and the other side of the die has the probe marks toward the inside of the die.

Extra care taken to align the probes will contribute to reduce setup costs, longer probe life and higher yield through faster setup and improved contact.

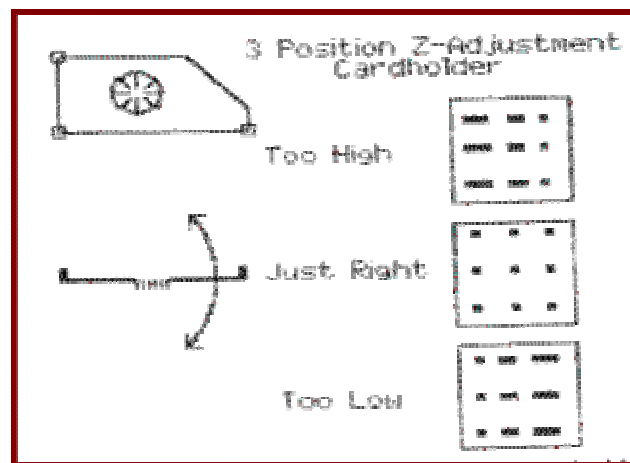
SYSTEM PLANARITY

The cardholder in the prober should be calibrated to be flat and parallel to the top surface of the chuck. This will insure the simultaneous contact of all the probe tips. If the cardholder or chuck is out of plane in relation to the other, probes on one side of the die will touch down before the other side of the die. The lower probes will scrub more than the higher probes and the problem can be easily identified with visual QC. Probers that are designed with three position z-adjustment cardholders (such as Electroglass 1034) should be checked and calibrated regularly. These probers have only one z adjustment position where the table is flat and parallel to the device chuck and lead screw axis. In the example illustrated below only one position of the table provides uniform probe marks.

When the table is not adjusted properly, some of the probes are lower on one side of the device and higher on the other. The lower probes contact before the high probes and produce a longer scrub mark. Similar results occur if the device chuck is not parallel to the cardholder and lead screw axis.

Good system planarity implies that the prober (or device handler for laser trim systems) is checked regularly as part of a routine preventative maintenance program. This will insure that the cardholder and device chuck are flat and parallel to an established reference plane (usually the lead screw axis or air-bearing surface of the prober).
